ASIA **TURBOMACHINERY** & **PUMP** SYMPOSIUM
MARCH 2018 | SUNTEC SINGAPORE

Investigation and Resolution of Governing Valve Linkage Failure for Compressor Drive Steam Turbine

Abstract

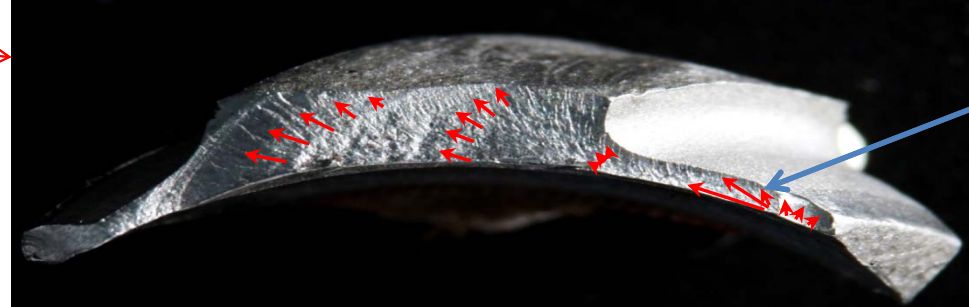
Fractured

Worn out thickness was roughly 2mm and striation pattern was observed which helped us identify fatigue fracture.

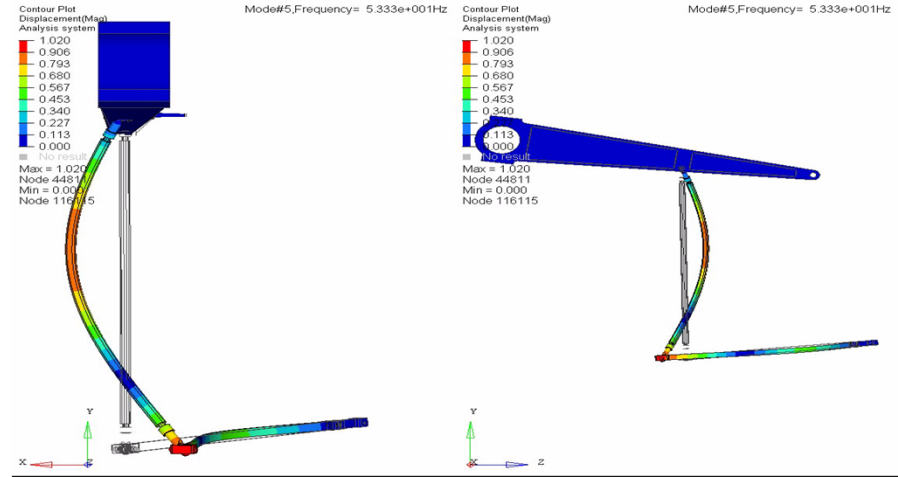
4th vibration mode

Fatigue fracture pattern and vibration analysis indicated that the 4th resonance mode falls in the Turbine operation range.

- *Plan 1 (Applied)*: Provide separation margin from resonant excitation frequency.
- *Plan 2*: Improve system integrity using a redundant system.

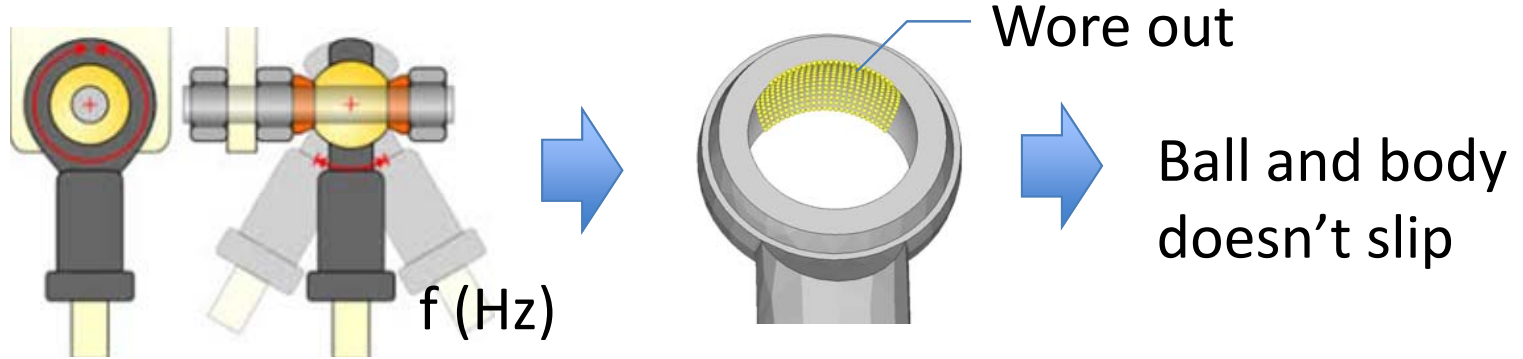
- PTFE liner wore out due to resonance vibration (4th mode).

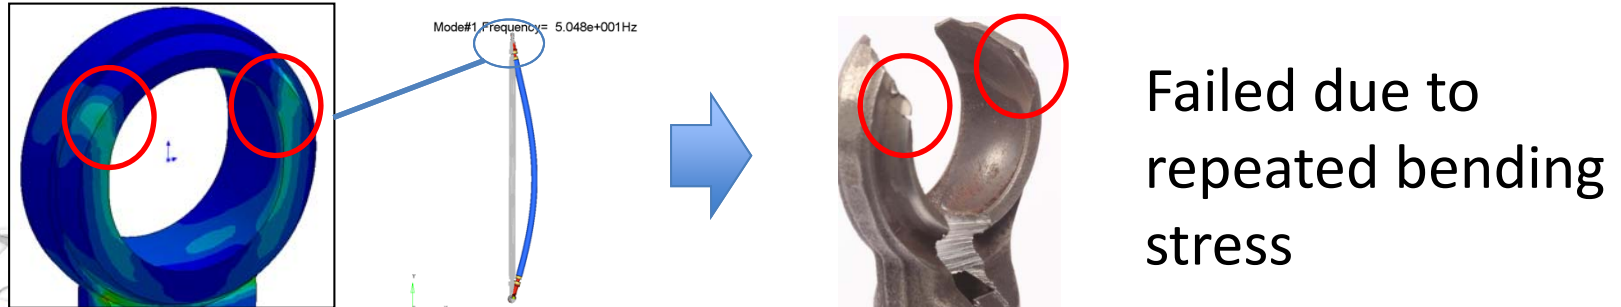
- Bending stress occurred due to resonance vibration.

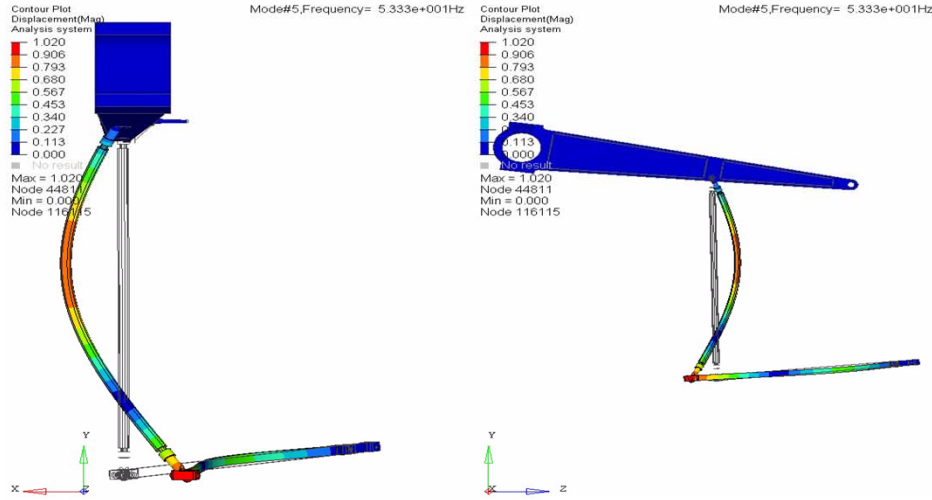
(4th mode : 51.6Hz)

Slip velocity (5.6 mm/sec),
Lh = 16,644 hr (1.9 years)

Under resonance condition, PTFE liner will wear out within 1.9 years of operation.

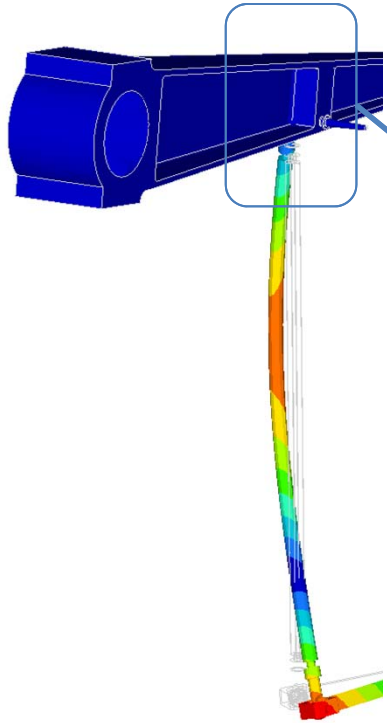
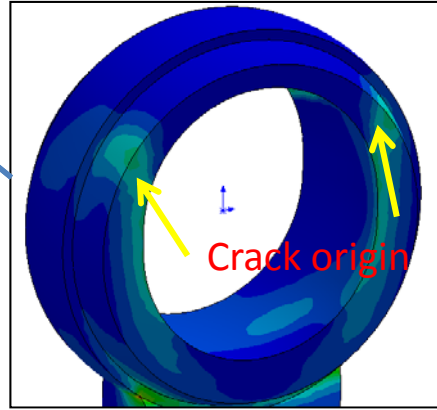
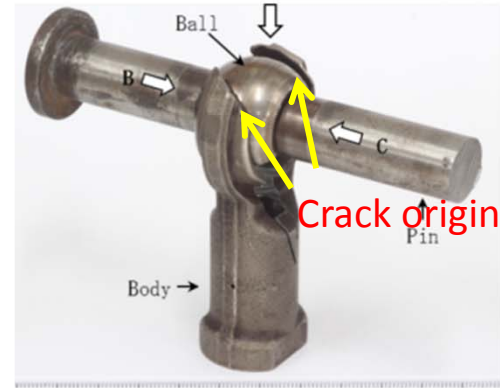
The peak stress points due to vibration at resonant frequency was found using FEA. They match the crack origin point of the failed bearing.

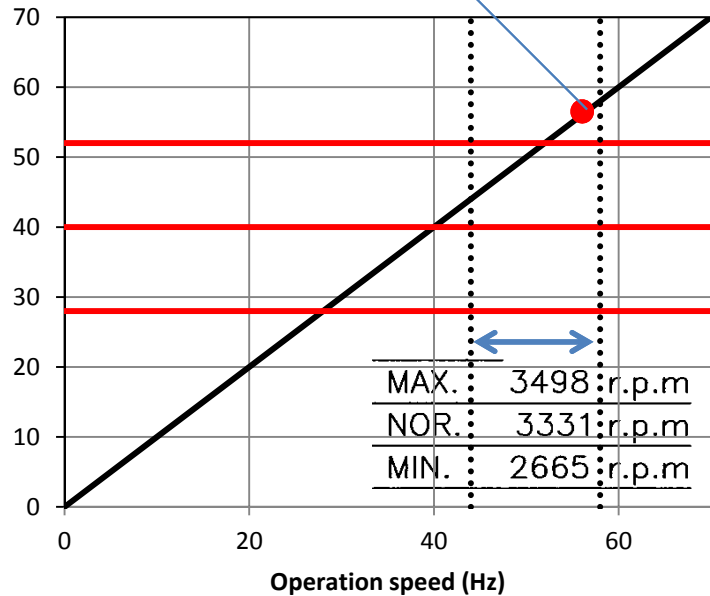
Current operation

As a result of modification (Plan 1), turbine operation speed is far away from the resonance frequency.
No issues experienced after the maintenance.
